UNITED STATES DISTRICT COURT
SOUTHERN DISTRICT OF CALIFORNIA

Case Number Case No. C 07cv2107
MMA

**DECLARATION OF DR. ROBERT
N. ANDERSON IN SUPPORT OF
PLAINTIFFS' MOTION FOR
LEAVE TO SUPPLEMENT
EXPERT DISCOVERY AND IN
SUPPORT OF OPPOSITION TO
DEFENDANTS' MOTIONS FOR
SUMMARY JUDGMENT AND
RELATED MOTIONS**

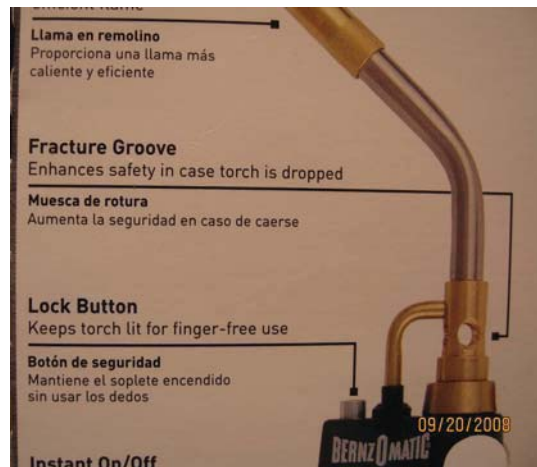
21
22
23
24
25
26
27
28 fig. 5

15 Mr. Shalaby brought to my attention the existence of a safety “fracture groove”
16 located on the Bernzomatic TS4000 torch handles such as the one Mr. Shalaby was
17 using at the time of his injuries. Mr. Shalaby provided me with a package insert
18 accompanying his purchase of a TS4000 torch and cylinder kit a few days earlier. The
19 insert explains the fracture groove and its intended purpose, as shown in fig. 5 below.
20

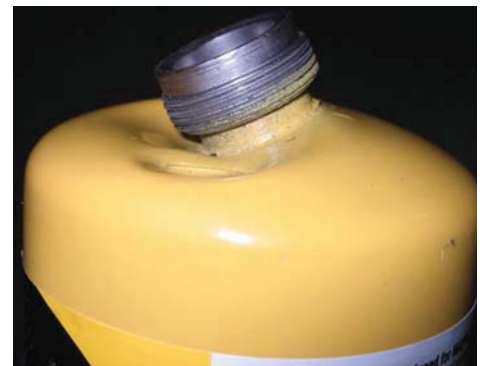
22 fig. 9

23 The cylinder used was one evidencing no defects at the bushing (compare fig. 9 to fig.
24
25
26
27
28

1 2 on page 2). A force of 152 pounds was applied directly to the torch handle, below
2 the fracture groove (fig. 8). The cylinder bushing (valve) began to bend at 15 foot-
3 pounds of force, and bent as shown in fig. 9, but did not breach or separate.

- (d) Consistent with the fact that the subject cylinder was not bent at the “dome” in the manner shown in fig. 9 (as opposed to at the “separation” bends shown in figs 10 and 11 above), the force applied to the tip of the torch handle Mr. Shalaby was using at the time of his injury was well below 15 foot-pounds (absence of bending means force was below 15 foot-pounds).
- (f) Consistent with Mr. Shalaby’s recollection, the point of impact was at very top of the torch, at the tip, above the fracture groove. It would have been impossible for the point of impact to have been below the fracture groove, because the direction of force was opposite the direction of the angle of the silver torch tube, exactly as shown in the exemplars, figs. 10 & 11 above, and any force sufficient to breach the cylinder would have broken the red plastic trigger button and left evidence of

21 therefore “greater than” 26 foot-pounds. The absence of a bend at the dome area (see
22 fig. 9) establishes the force could not have exceeded 15 foot-pounds. In this instance
23 the separation occurred at an estimated 3 foot-pounds or less. The absence of any
24 evidence impact to the torch handle, and the fact that the fracture groove was not
25 fractured, further prove with engineering certainty Mr. Shalaby’s injuries were caused
26 by a defective cylinder.
27
