UNITED STATES DISTRICT COURT
SOUTHERN DISTRICT OF CALIFORNIA

Case Number Case No. C 07cv2107
MMA

**DECLARATION OF DR. ROBERT
N. ANDERSON IN SUPPORT OF
PLAINTIFFS' MOTION FOR
LEAVE TO SUPPLEMENT
EXPERT DISCOVERY AND IN
SUPPORT OF OPPOSITION TO
DEFENDANTS' MOTIONS FOR
SUMMARY JUDGMENT AND
RELATED MOTIONS**

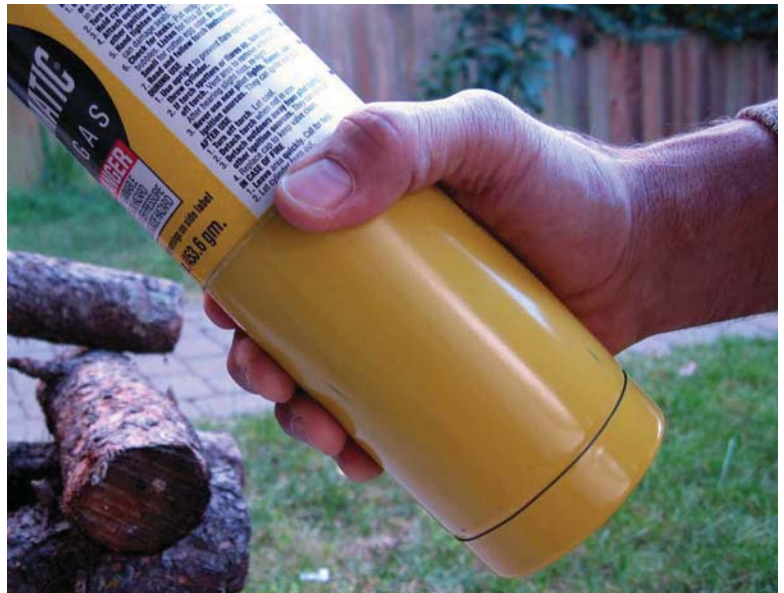
fig. 17

1
2
3
4
5
6
7
8
9
10
11 9. Figures 12-16, and the overall magnitude of the injuries, indicate Mr.
12 Shalaby was at the epicenter of the “ball of fire” which engulfed him from head to
13 tow. Fig. 17 reveals that the inside of his right hand was not burned because it was
14 protected from the flames by the cylinder, with exception of injury to the exact portion
15 of his hand which was exposed (fig. 18). Figures 17 and 18 in particular indicate that
16 the cylinder was in Mr. Shalaby’s hand at the moment of breach, while Defense expert
17 Thomas Eager accurately explained that the MAPP gas cylinder would only breach
18 when placed in a fire if a pressure relief valve located on top of the cylinder would
19 have failed, and the injury would have been localized from only one direction, not
20 circumferentially from head to toe. The recently discovered photos therefore disprove
21 the defendants’ theory that the cylinder had been kicked, on grounds of impossibility,
